INVESTIGATION OF TENSION-COMPRESSION  
FATIGUE BEHAVIOR OF A UNIDIRECTIONAL  
METAL MATRIX COMPOSITE AT ELEVATED  
TEMPERATURE

THESIS

Darren L. Kraabel, 2nd Lieutenant, USAF

**AIR FORCE INSTITUTE OF TECHNOLOGY**

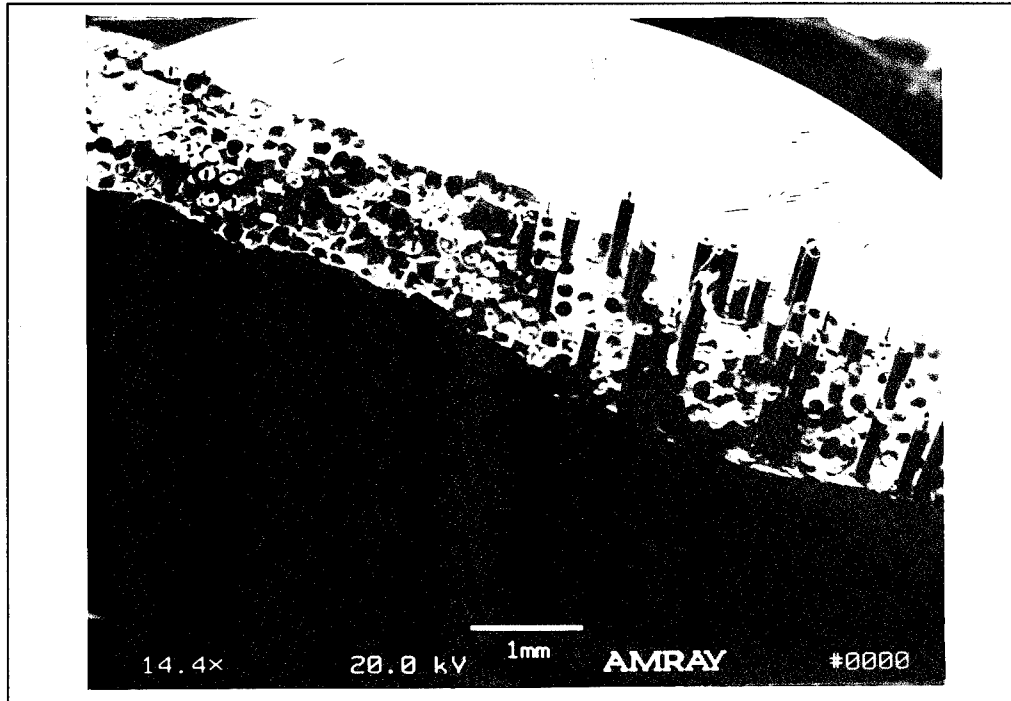
**Figure 29. Fracture Surface at 700 MPa, TC HT**

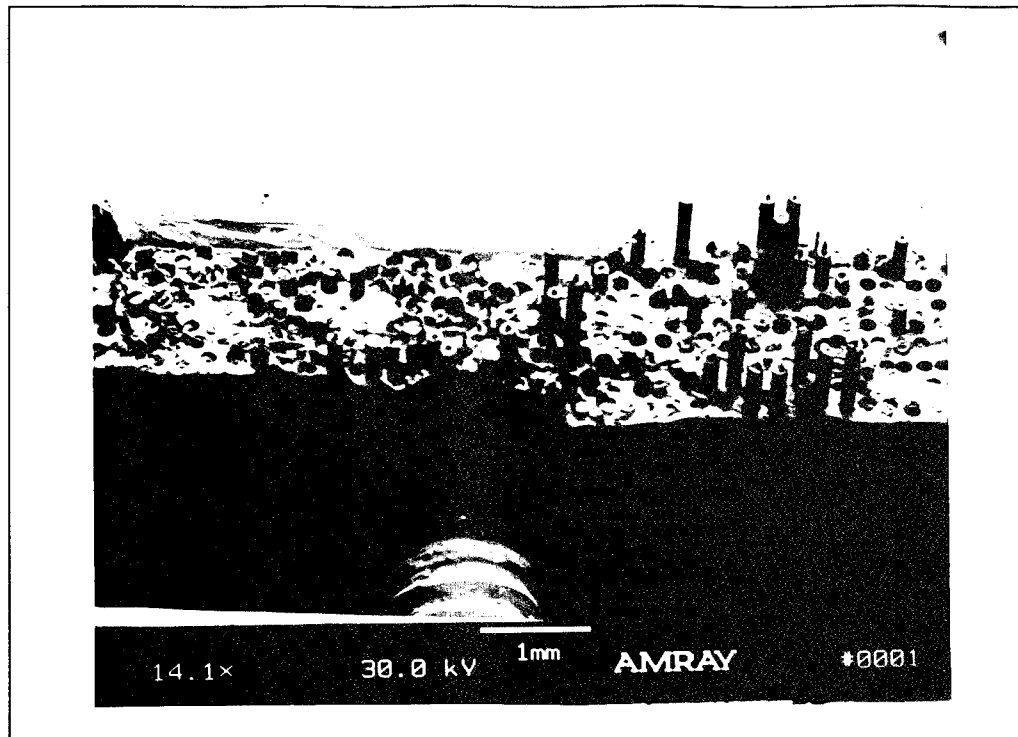
**Figure 30. Fracture Surface at 625 MPa, TC HT**

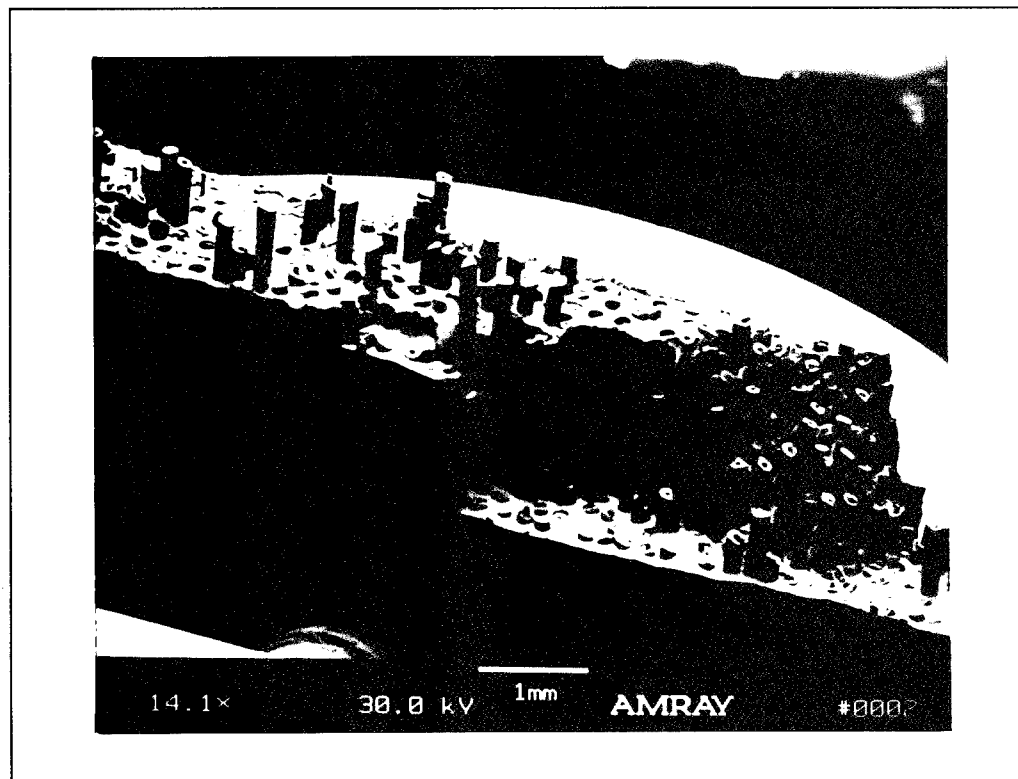
**Figure 31. Fracture Surface at 425 MPa, TC HT**

Figure 31 shows many levels of flat area while Figure 28 shows a single level. This indicates that many cracks were progressing through the composite at low stress. As the stress level increases, one crack tends to dominate resulting in a single level of flat fracture surface area.

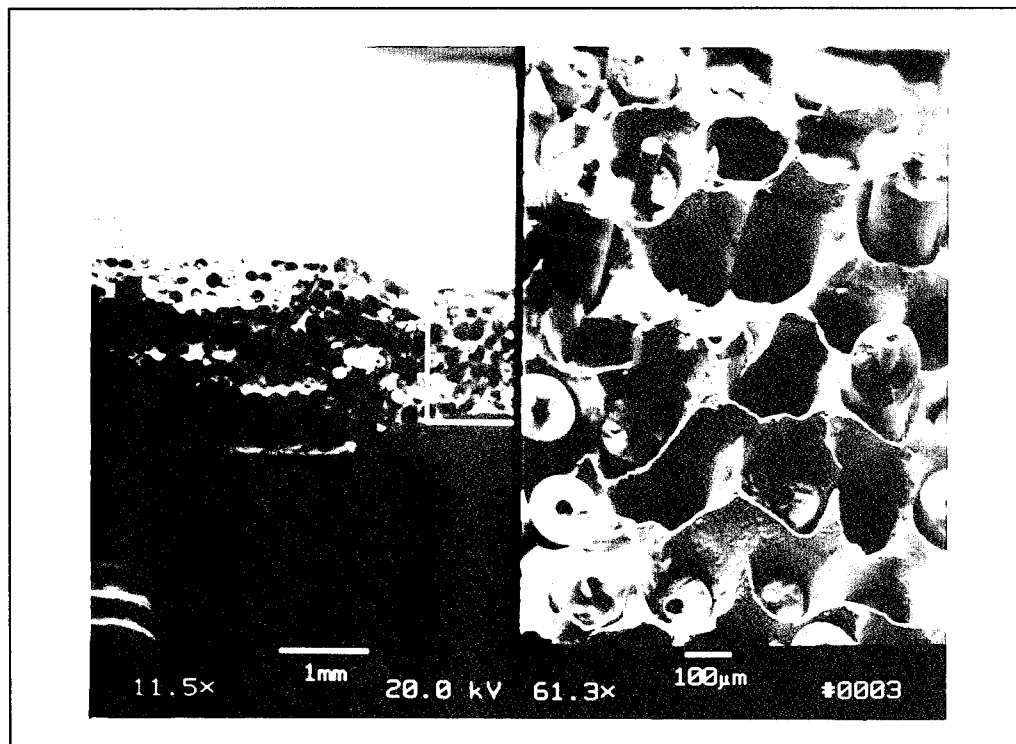
**Figure 32. Matrix necking, 800 MPa, TC HT**

While all specimens show some flat area where the fibers remain intact, there also exists an area of fiber pull-out in each case where extensive matrix necking has occurred. Figure 32 shows extensive fiber-matrix debonding in the necked portion of the 800 MPa fracture surface. A closer examination of necked region of the 800 MPa specimen shows ductile void coalescence which is seen as dimples in Figure 33. This indicates that the fibers failed first followed by matrix failure caused by overload in tension. The overload resulted from a smaller amount of fibers carrying the same applied stress. The fibers in the necked region were carrying all the load since the other fibers had already fractured behind the advancing matrix crack tip.

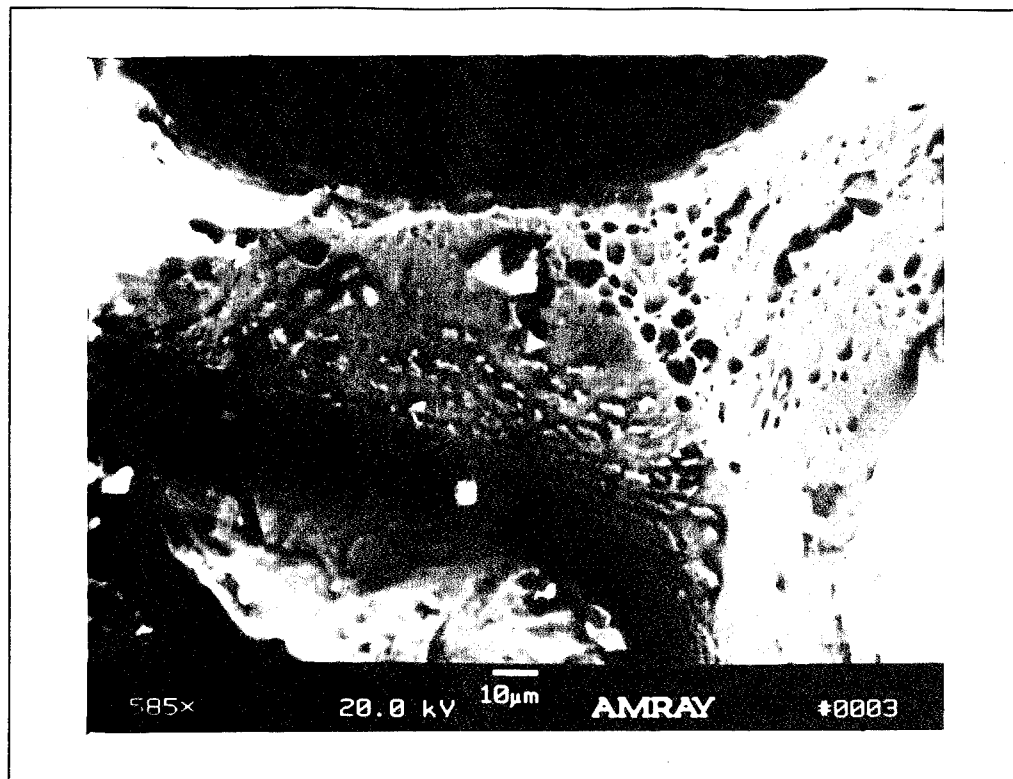
**Figure 33. Ductile void coalescence, 800 MPa, TC HT**

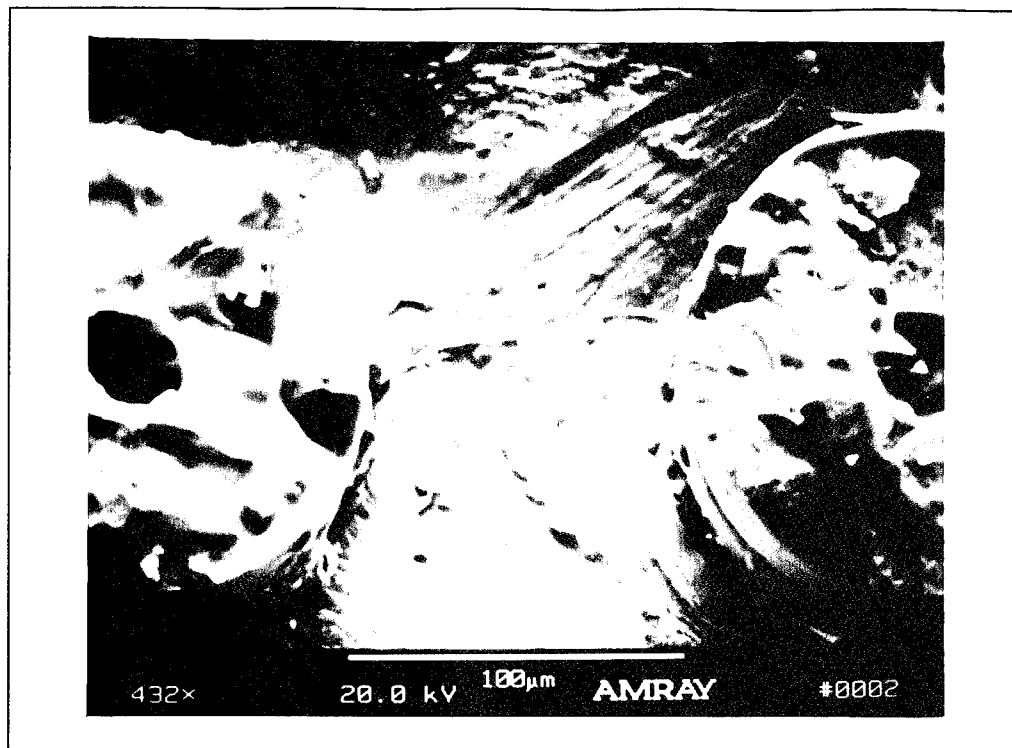
**Figure 34. Fatigue Striations, Intact Fibers, 700 MPa, TC HT**

Examination of the flat portions of the fracture surface provide strong evidence of matrix fatigue crack growth caused by cycling. Figure 34 shows the flat area of the fracture surface at 700 MPa. It consists mainly of fibers that have remained intact. The fibers that appear to have pulled out of the matrix material in the flat region of the fracture surface are caused by random fiber failure as the matrix crack progresses throughout the specimen. Additionally, very little fiber-matrix debonding has occurred. Closer examination yields the presence of fatigue striations in the matrix caused by fatigue cracking. The striations grow parallel to the direction of the crack growth. In Figure 34, cracks can be seen growing from a few different directions.

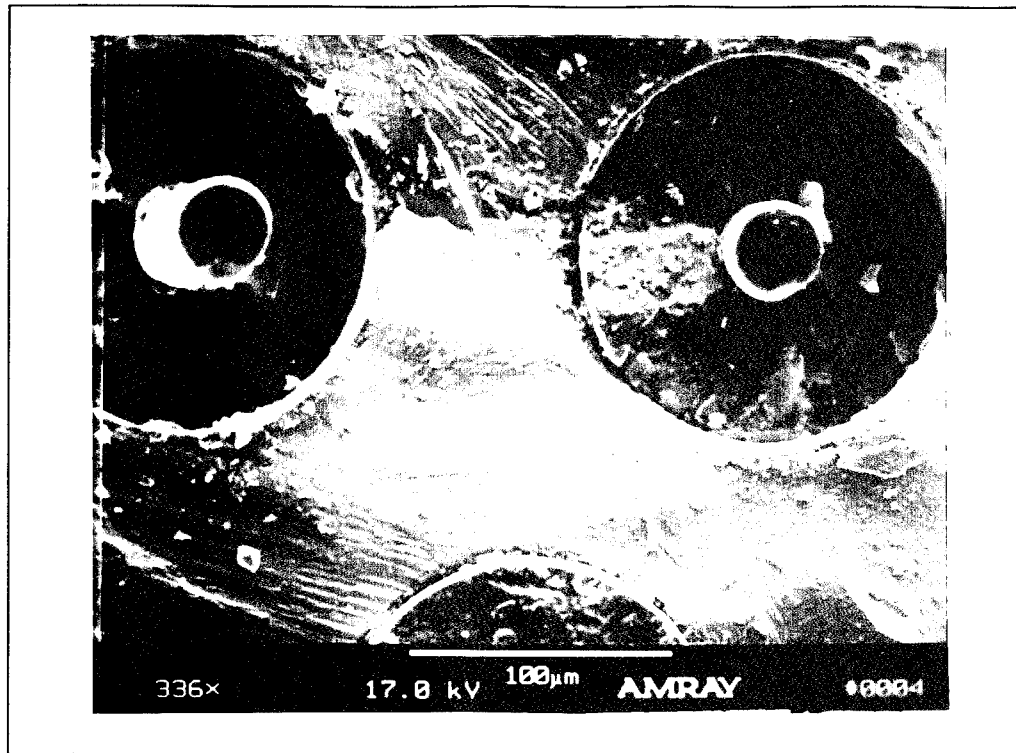
**Figure 35. Fatigue Striations, 425 MPa, TC HT**

Whereas fatigue striations are present at 700 MPa, they are also found at lower stresses including the specimen cycled at 425 MPa. Recalling that as the surfaces at 800, 700, and 625 MPa contained areas of matrix necking and fiber pull-out, the surface of the 425 MPa specimen is completely flat. All the fibers appear to be intact with little or no fiber-matrix debonding. Initially it may appear that a different failure mechanism is occurring at lower stresses but the presence of fatigue striations, shown in Figure 35, across the entire surface describe numerous matrix cracks growing from different directions. Thus, failure is dominated by matrix cracking at low stresses as well as higher stresses. The progression of matrix cracking, however, requires the previously described group separation. Specimen sectioning clearly illustrates the difference in matrix crack growth between groups 1 and 2.

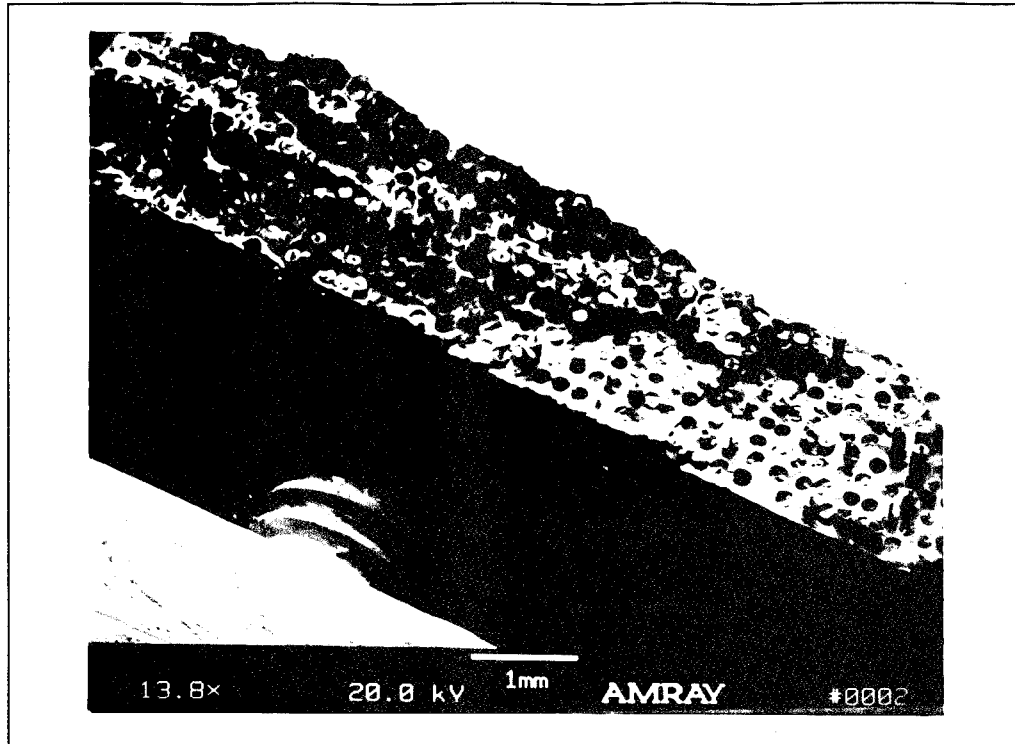
**Figure 36. Fracture Surface, 800 MPa, TT HT**

The examination of the micro-mechanical behavior of tension-tension fatigue loading was limited to the specimen cycled at 800 MPa since it was the only one used for comparison of failure mechanisms. The fracture surface shown in Figure 36 consisted of a small flat portion and a much larger, uneven area where fibers pulled out of the matrix. This is similar to the fracture surface at 800 MPa under tension-compression loading conditions. The flat region indicated matrix cracking while the uneven region once again indicated failure by tensile overload. The only difference between tension-tension and tension-compression loading is the amount of flat area. For the tension-tension loading case, the flat region is much smaller indicating that more of the surface was dominated by fiber pull-out.

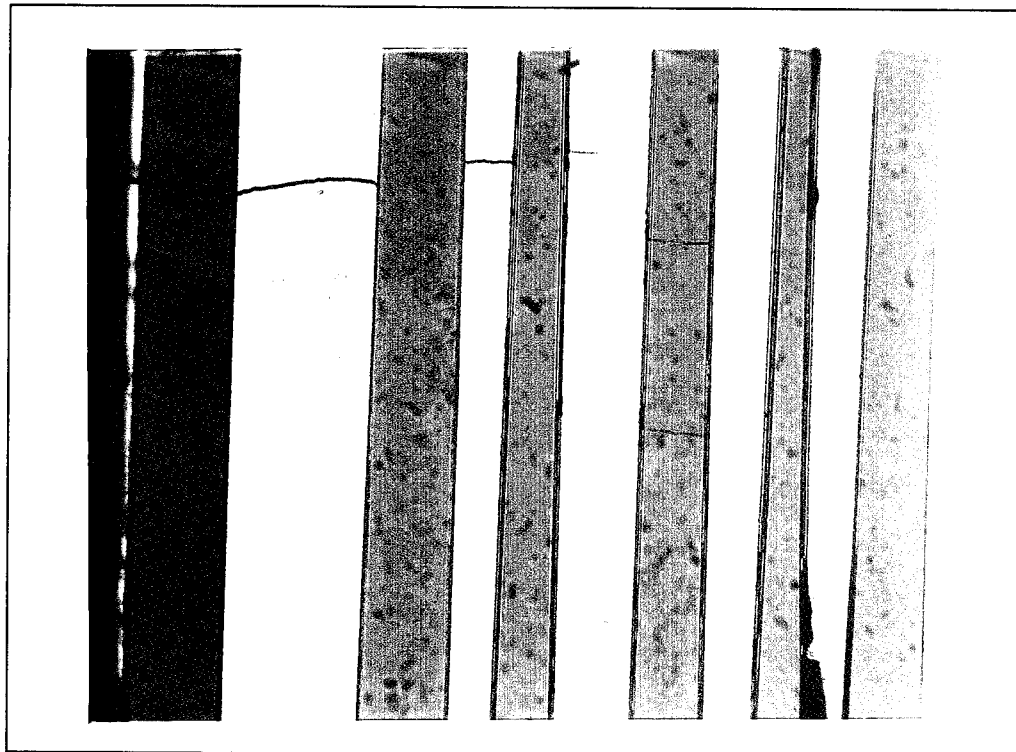
**Figure 37. Matrix and fiber cracking, 800 MPa, TC HT**

density of matrix cracks at 700 MPa is roughly the same as that observed at 800 MPa. Thus, in Group 1, damage consists of minimal matrix cracking and even less fiber cracking. It should also be noted that even though fiber bridging did occur, the number of fibers bridged by the matrix crack is minimal when compared with that observed in Group 2. The lack of fiber bridging in these specimens suggests that as matrix cracks developed, one of these cracks became dominant. As the dominant crack propagated through the composite, the additional stress carried by the fibers exceeded the fiber's ultimate strength causing them to fail directly behind the advancing crack tip. Thus, crack propagation is rapid and does not allow the other matrix cracks to mature.

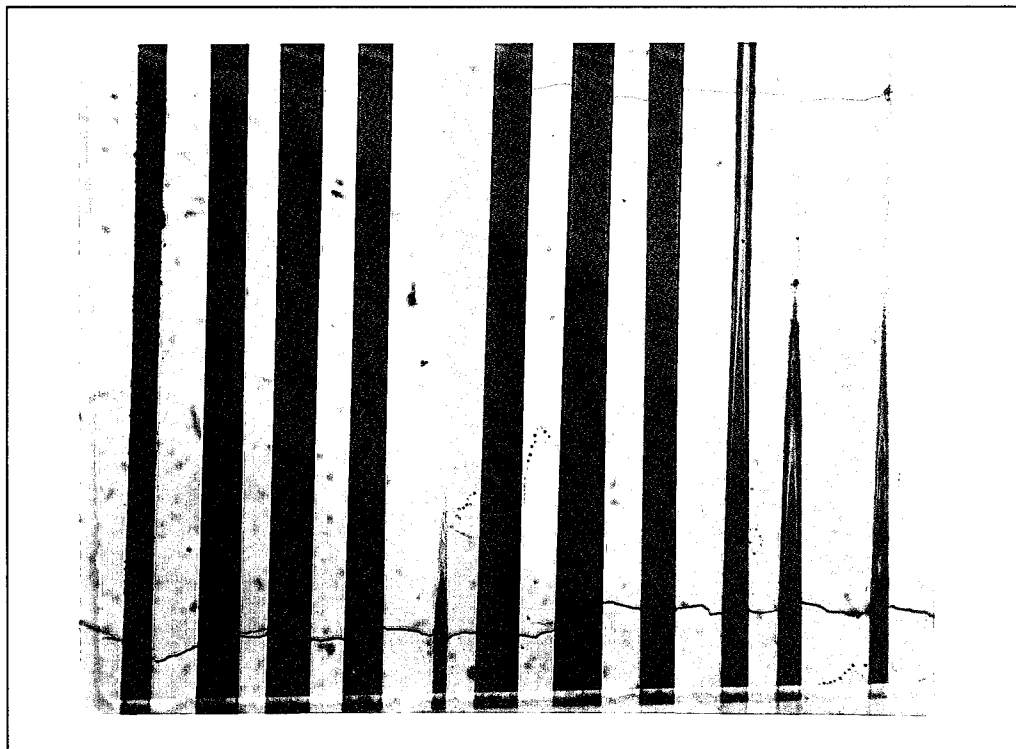
**Figure 38. 625 MPa Fiber Bridging**

The damage observed in Group 2 consists of matrix cracking and extensive fiber bridging. As shown in Figures 38-40, the matrix cracks all grow across many lines of fibers without causing fiber failure. This phenomenon, called fiber bridging, was also noted by Sanders in matrix dominated failure modes (33). As cracks grow, they encounter fibers which are much stronger than the matrix in which the cracks are growing. The fiber-matrix interface is relatively weak and rather than progress through the fibers, the cracks progress around them, often causing fiber-matrix debonding. Also seen in Figure 40 are molyweave. Since the molyweave act like precipitates in an alloy, they are strong crack initiation sites. In this specimen, however, cracks did not originate from the molyweave.

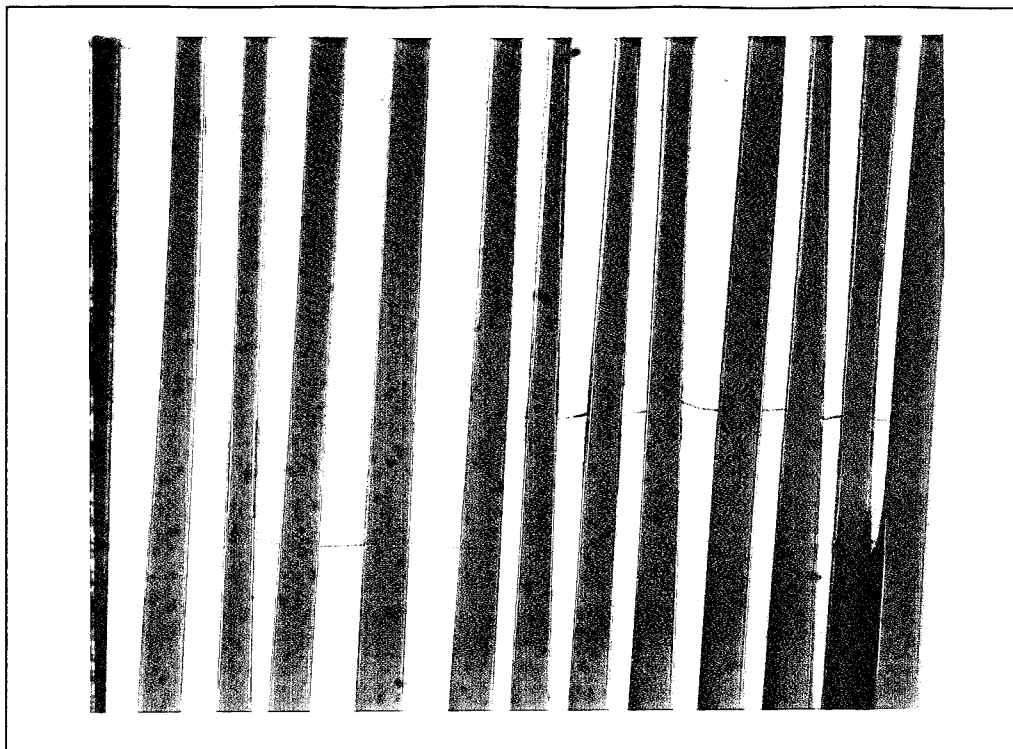
**Figure 39. 500 MPa Fiber Bridging, TC HT**

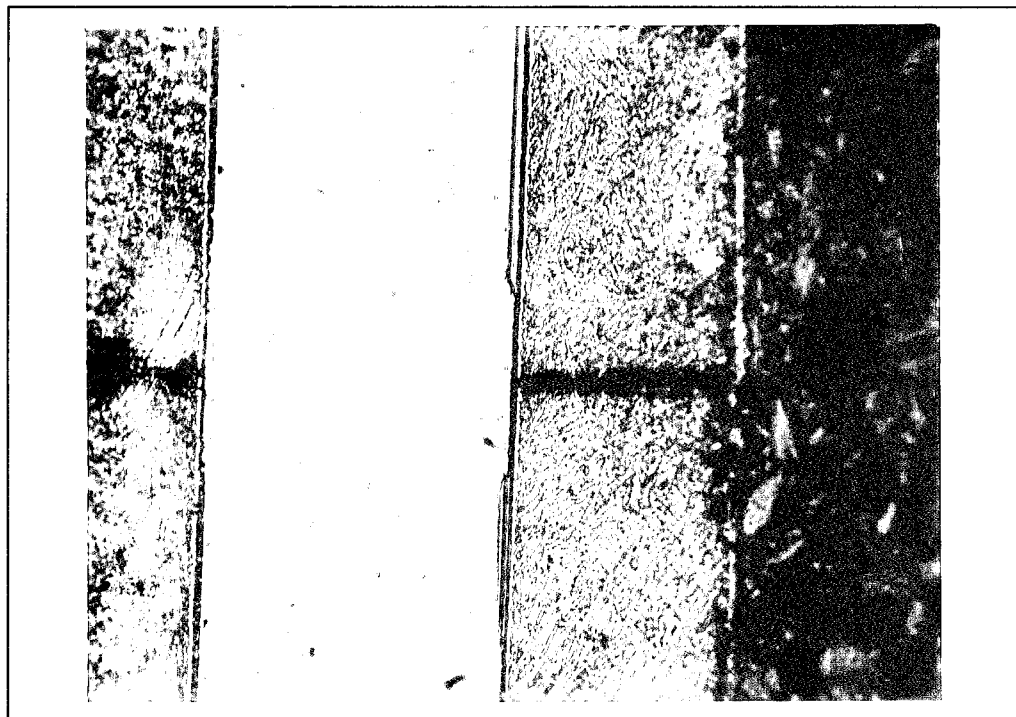
**Figure 41. Edge Crack Initiation, 625 MPa, TC HT**

Crack initiation sites were not limited to any particular region of the test specimens. While some cracks initiated on the edge of the specimen, Figure 41, others originated in the middle, Figure 42. This indicates that while the specimen edges are important crack nucleation sites, fatigue cracks can still develop within the material, far from the edge. Cracks that developed within the material initiated from fiber-matrix interface failure, as shown in Figure 42, caused either by other cracks that had bridged the fibers or by interface defects.

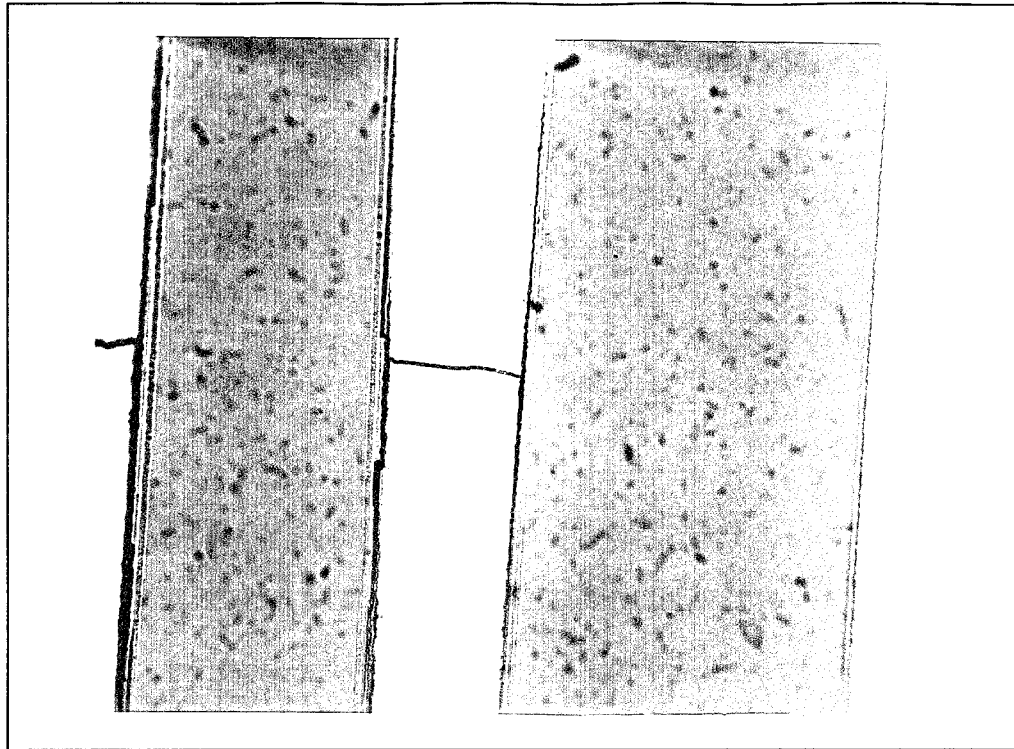
**Figure 42. Crack Initiation Within Specimen, 500 MPa, TC HT**

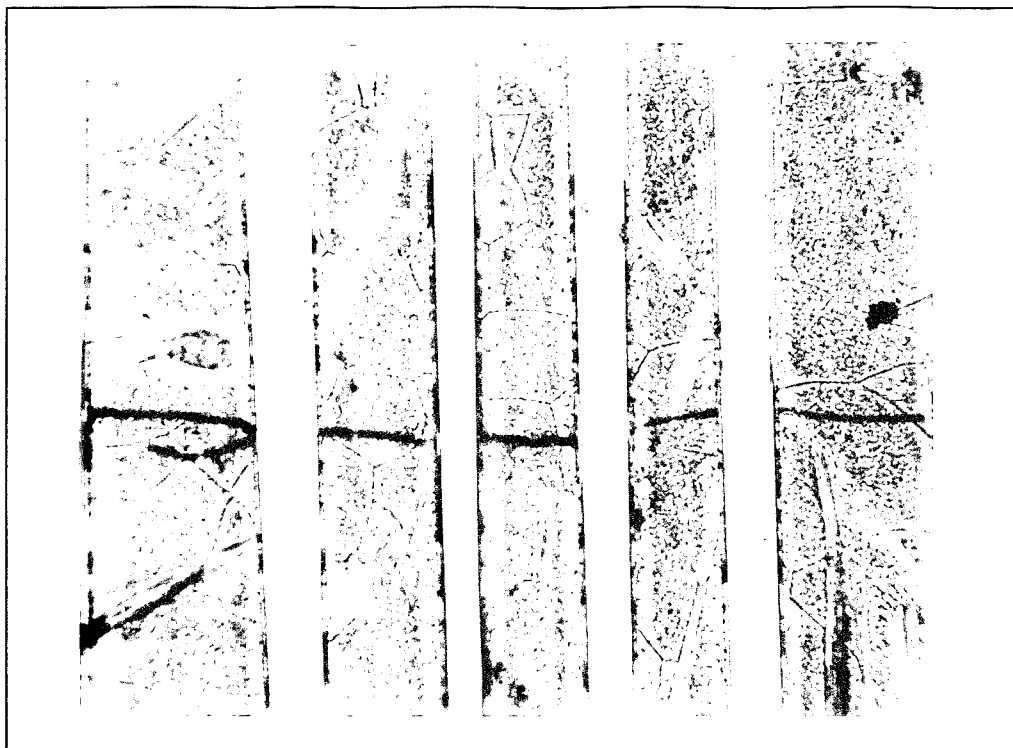
**Figure 43. Transgranular crack growth, 425 MPa, TC HT**

As can be seen from the sectioned samples, no fiber fracture was observed in Group 2. Evidence of matrix cracking was observed in all specimens, both on the fracture surface and in the sectioned samples. The necked regions of the fracture surfaces can now be explained by tensile overload while the flat areas contain strong evidence of fatigue crack growth.

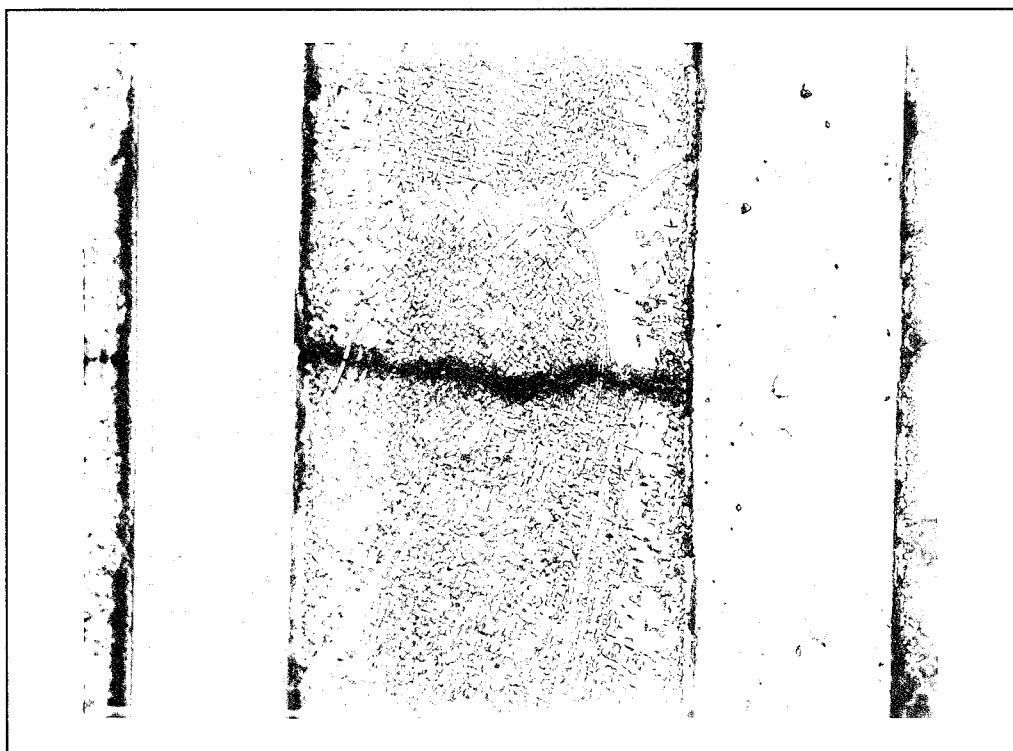
**Figure 44. Slip bands around crack, 425 MPa, TC HT**

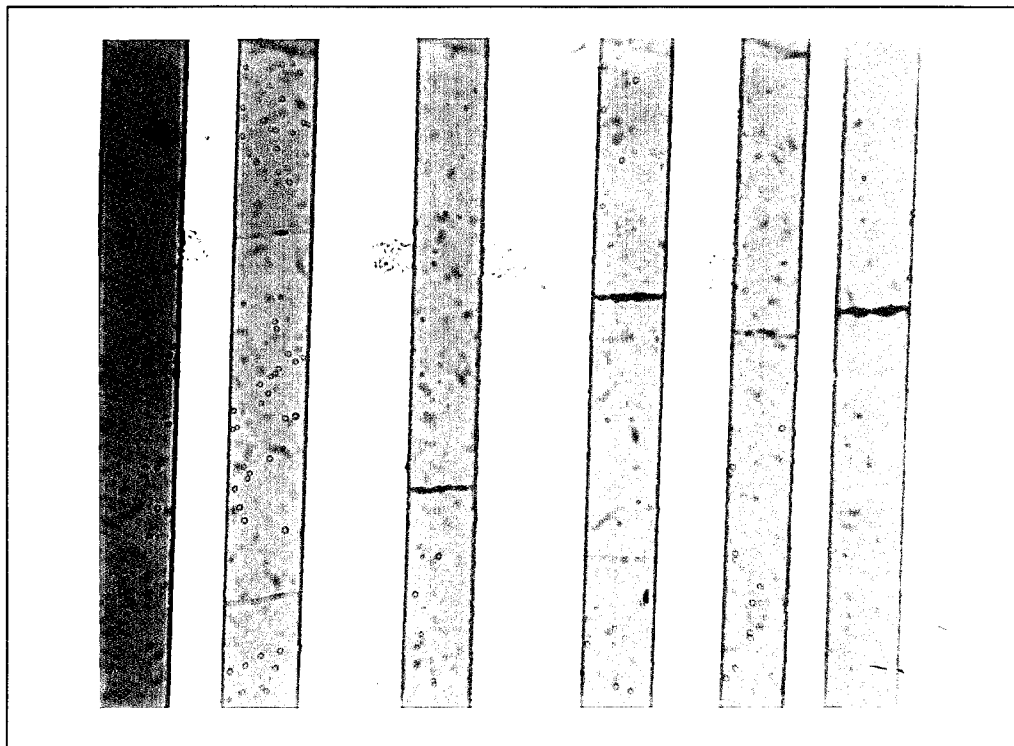
**Figure 46. Fiber fracture, 800 MPa, TT HT**

combined with the flat portion of the fracture surface suggest that the specimen failed under a combination of failure mechanisms which include both fiber and matrix fracture. Matrix creep observed in the strain trends previously discussed offers an explanation for fiber cracking. Majumdar and Newaz (24) have suggested that matrix creep results in a drop in matrix stress, forcing the fibers to carry more load, hence causing fiber cracks.

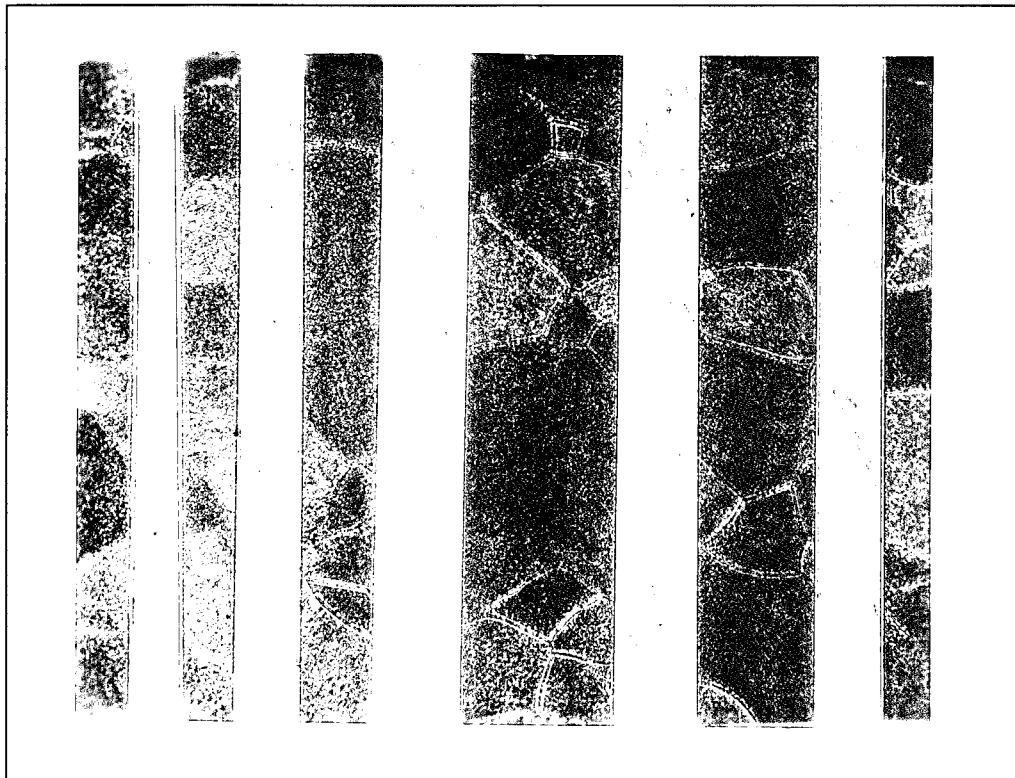
**Figure 47. Etched Face Specimen, 800 MPa**

corresponding to 800 MPa falls well below that limit. Also, a micro-mechanical analysis in Appendix A shows that the matrix stresses at 800 MPa are far below the proportional limit of the matrix material. Therefore, to obtain matrix plasticity, the laminate must be cycled above 0.55% maximum strain regardless of the loading type, e.g. tension-tension vs. tension-compression.

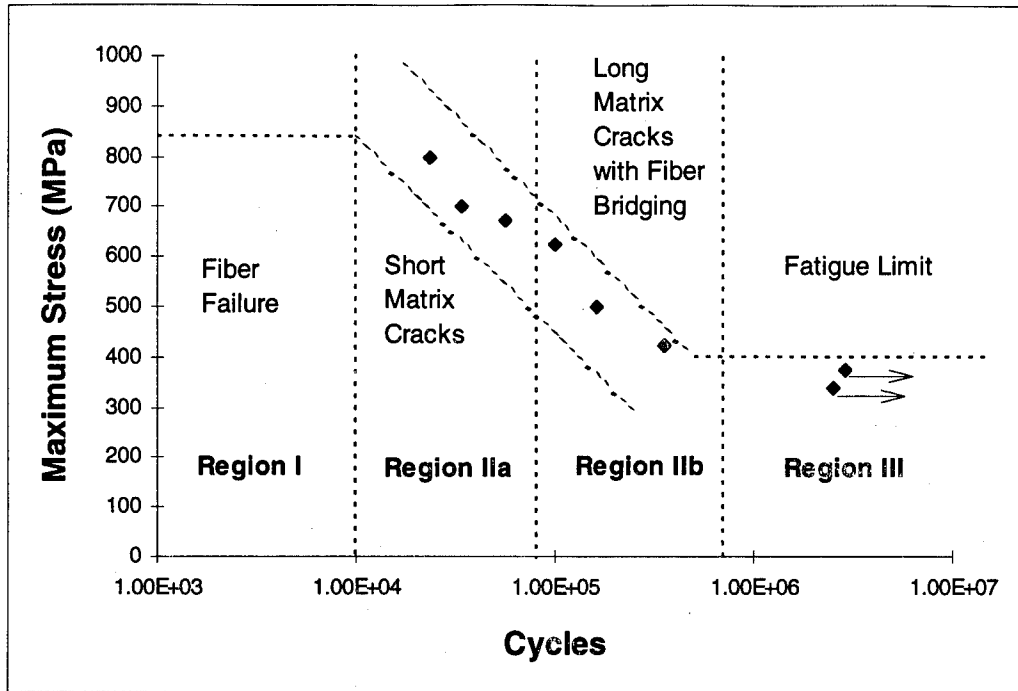
Figure 48.  $[0]_8$  Tension-Compression Fatigue Life Curve

Specimens in Group 3 fall within this region.

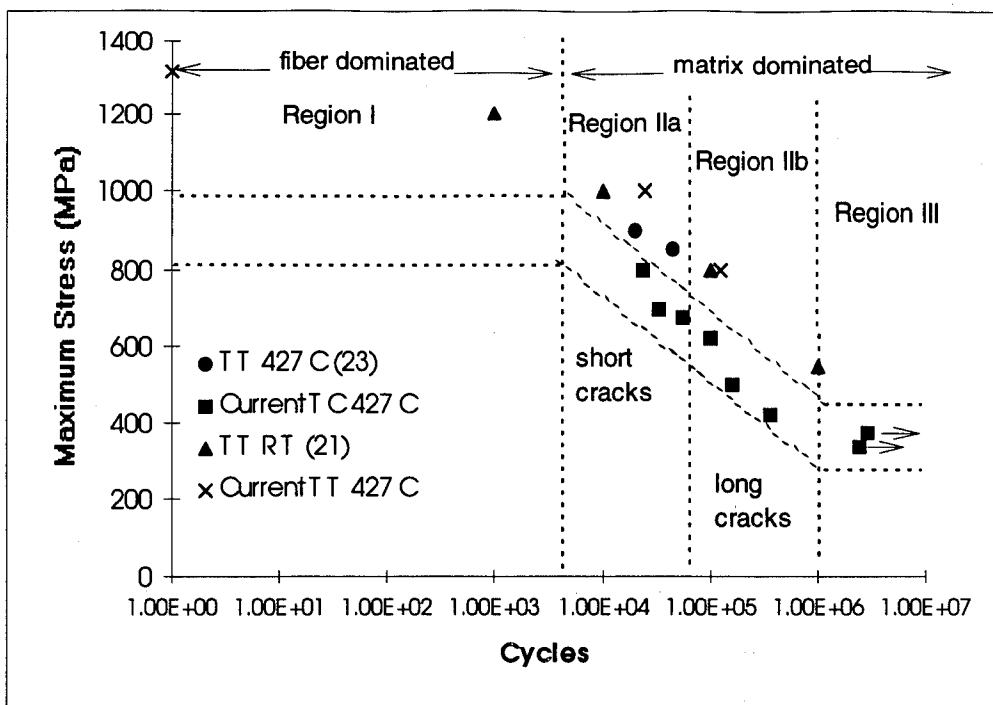
Figure 49. Maximum Stress Fatigue Life Curve

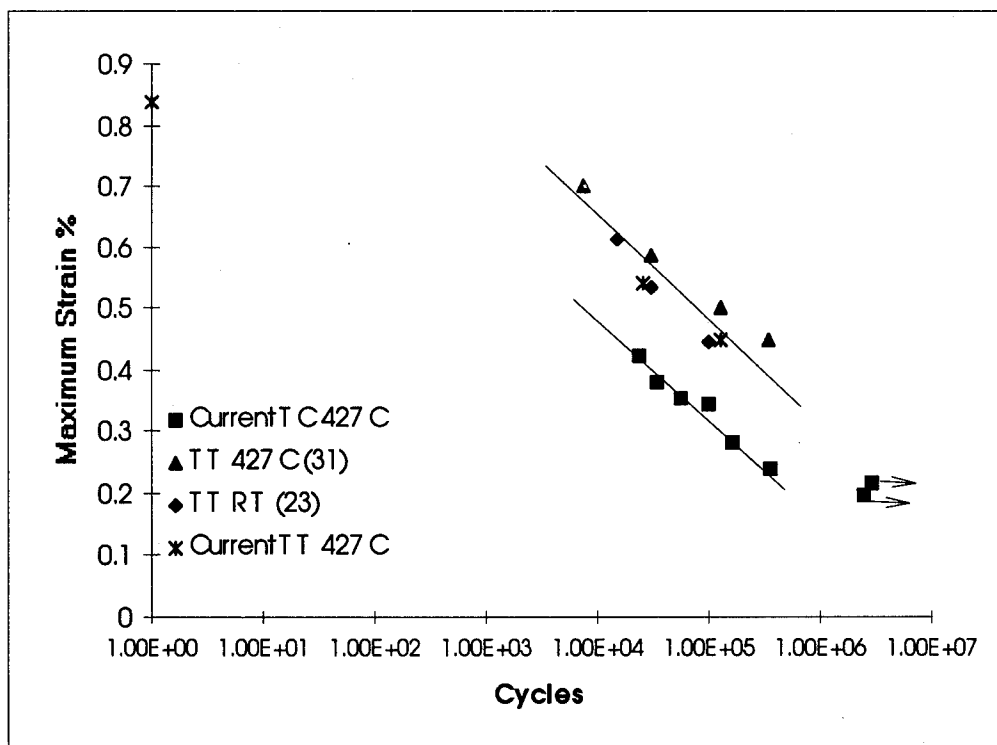
Figure 50. Maximum Strain Fatigue Life Curve

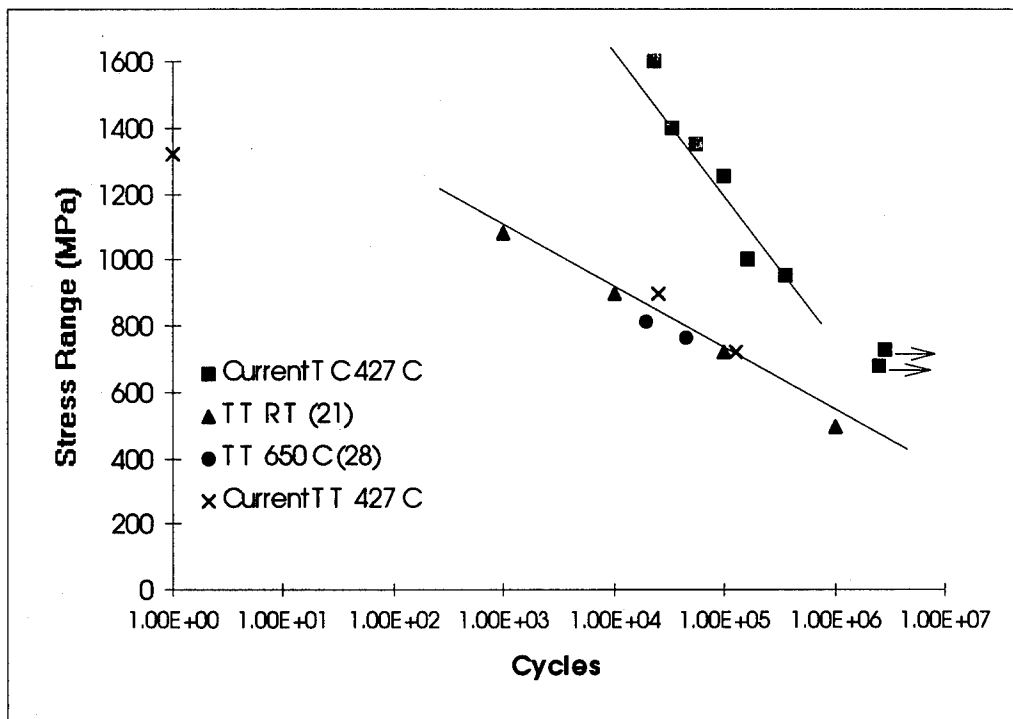
Figure 51. Stress Range Fatigue Life Curve

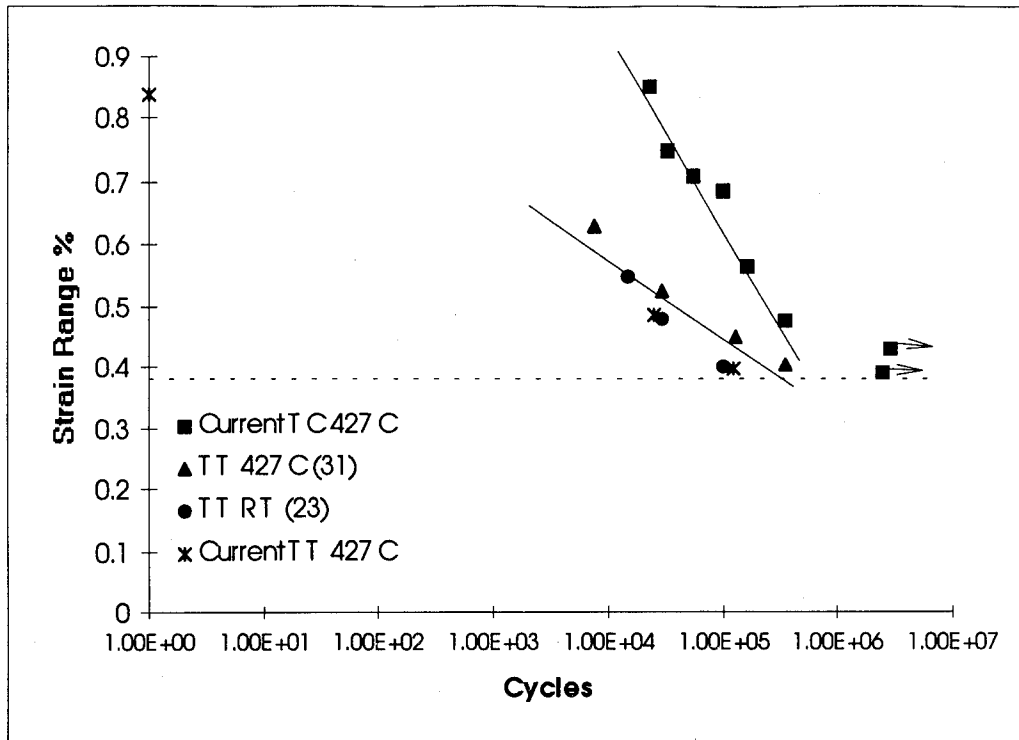
**Figure 12. Strain Range Fatigue Life Curve**

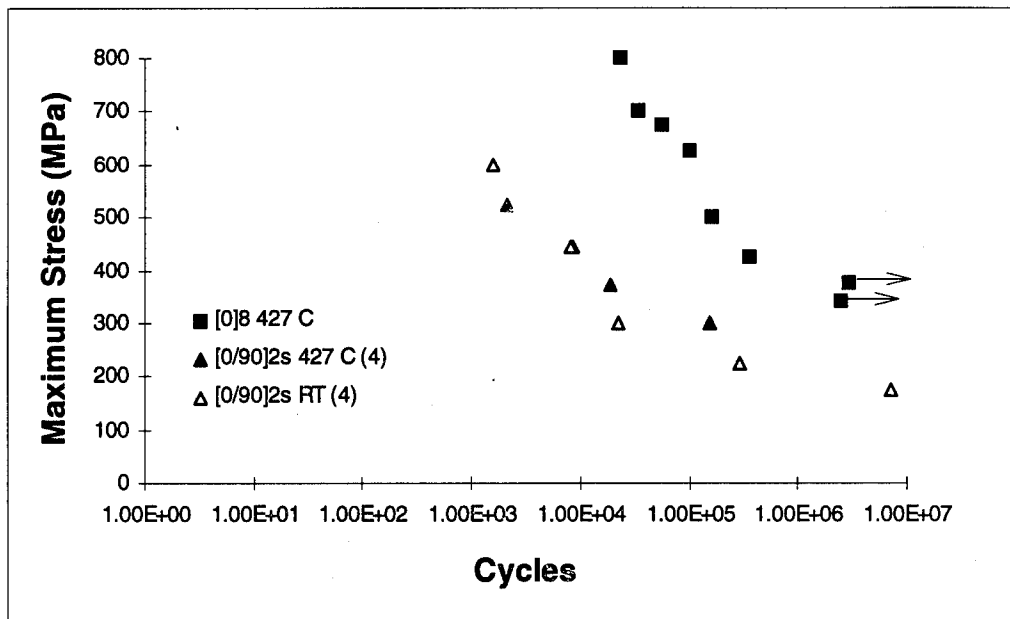
**Figure 53.  $[0]_8$  vs.  $[0/90]_{2s}$  Fatigue Life Comparison**

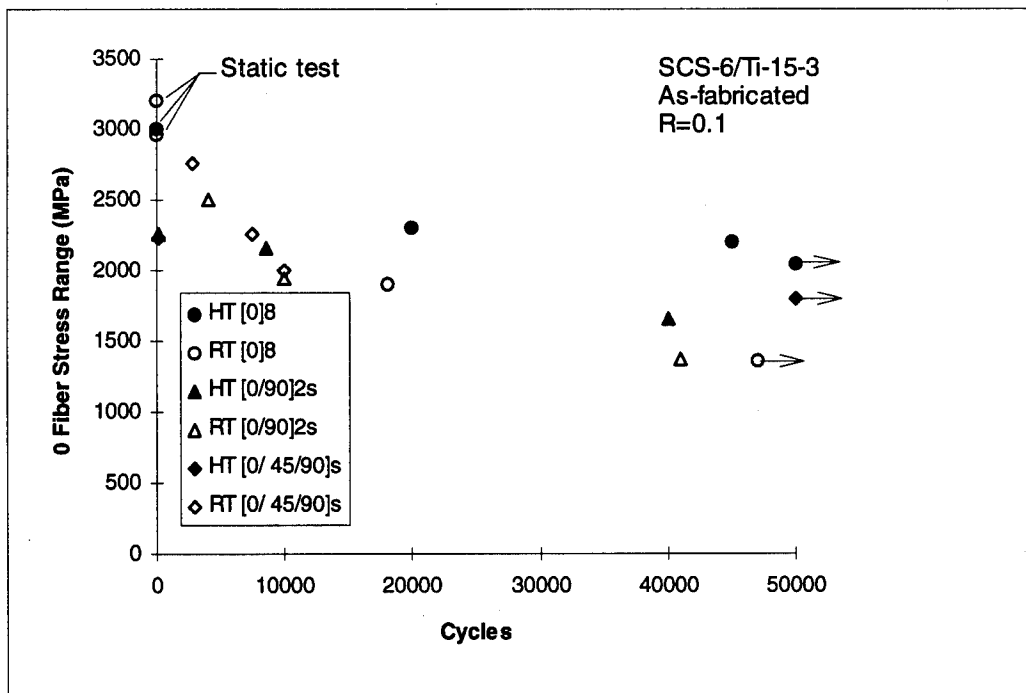
Figure 54.  $0^\circ$  Fiber Stress Fatigue Life Curve,  $R = 0.1$  (29)

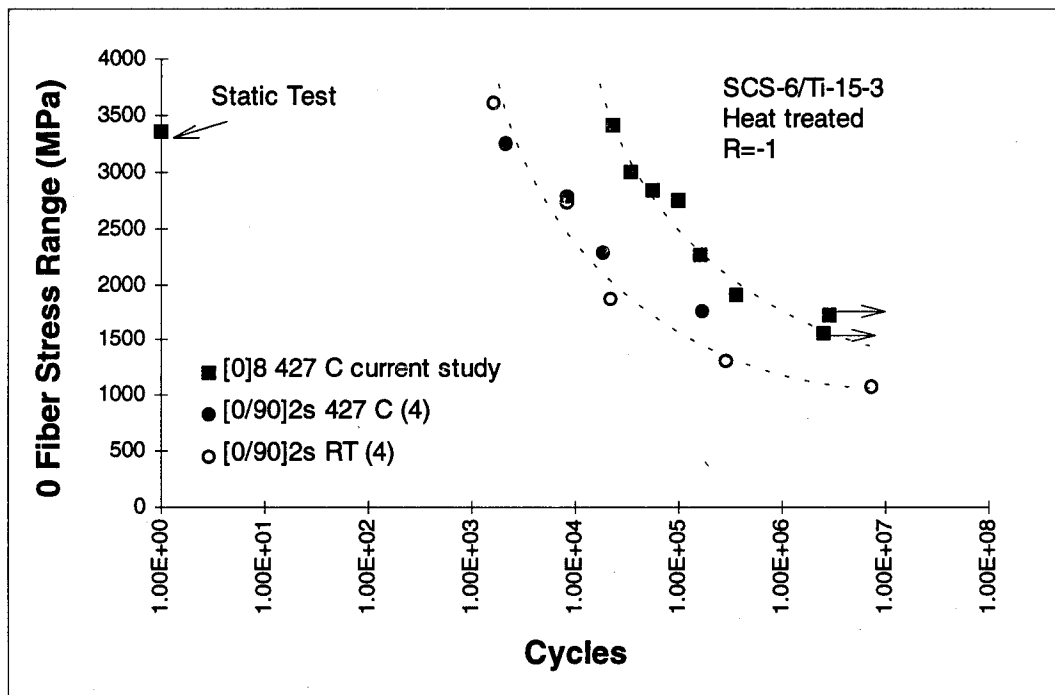
**Figure 55.  $0^\circ$  Fiber Stress Fatigue Life Curve,  $R = -1$**

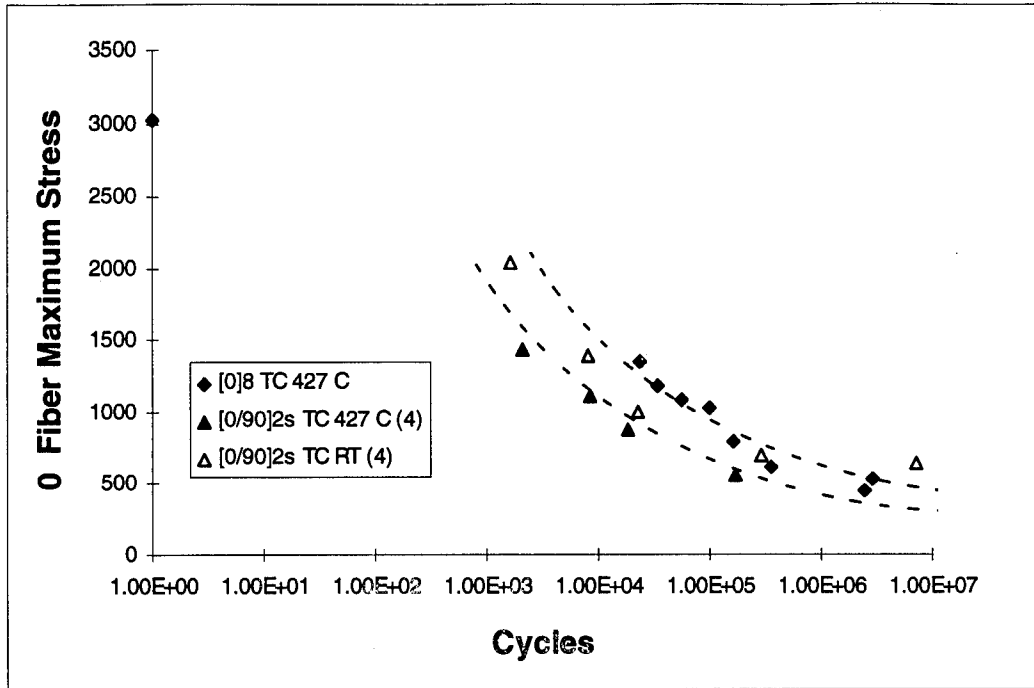
**Figure 56. Maximum 0° Fiber Stress Fatigue Life Curve,  $R = -1$**

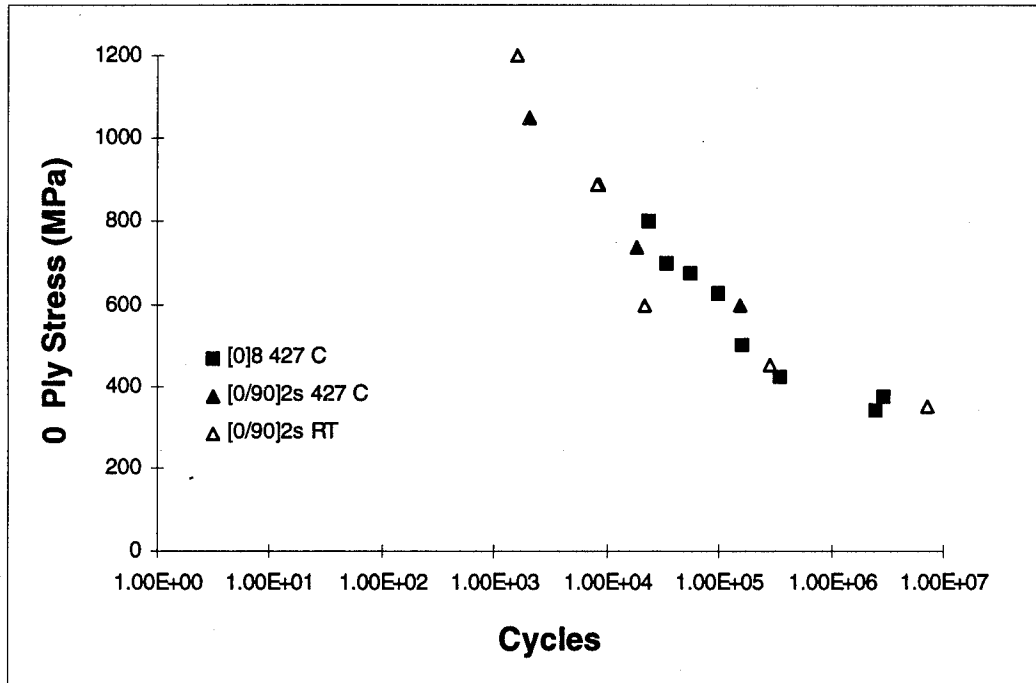
**Figure 57. 0° Ply Stress Fatigue Life Curve**

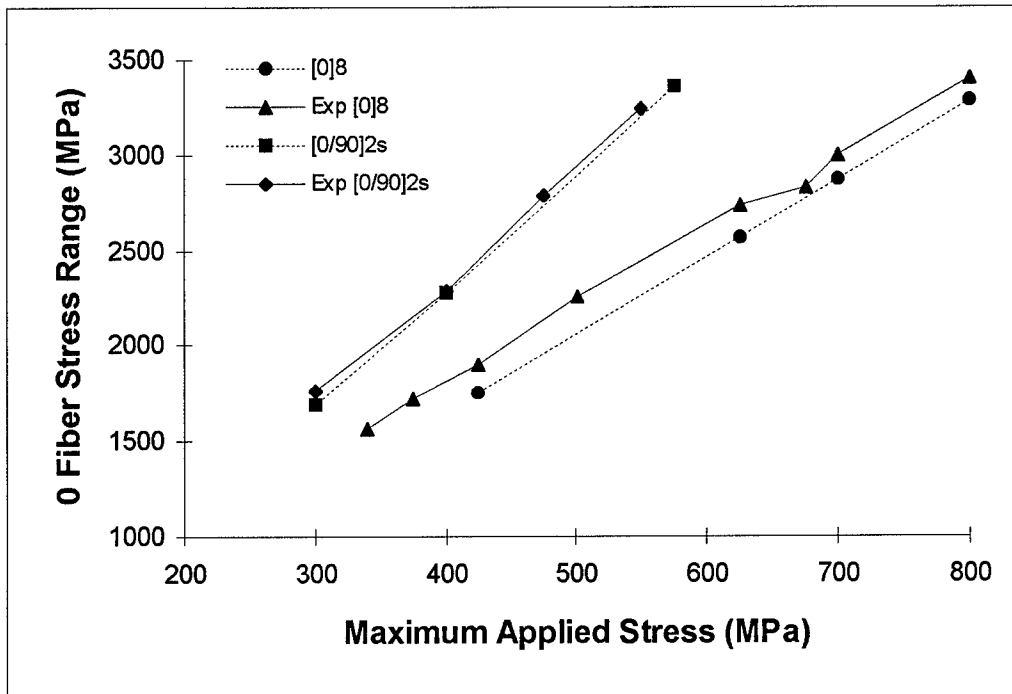
**Figure A-1. 0° Fiber Stress Correlation Between LISOL and Approximate Values**
